# **Debris/Ice/TPS Assessment and Integrated Photographic Analysis for Shuttle Mission STS-54**

**March 1993**

DEBRIS/ICE/TPS ASSESSMENT  
AND  
PHOTOGRAPHIC ANALYSIS  
OF  
SHUTTLE MISSION STS-54

January 13, 1993

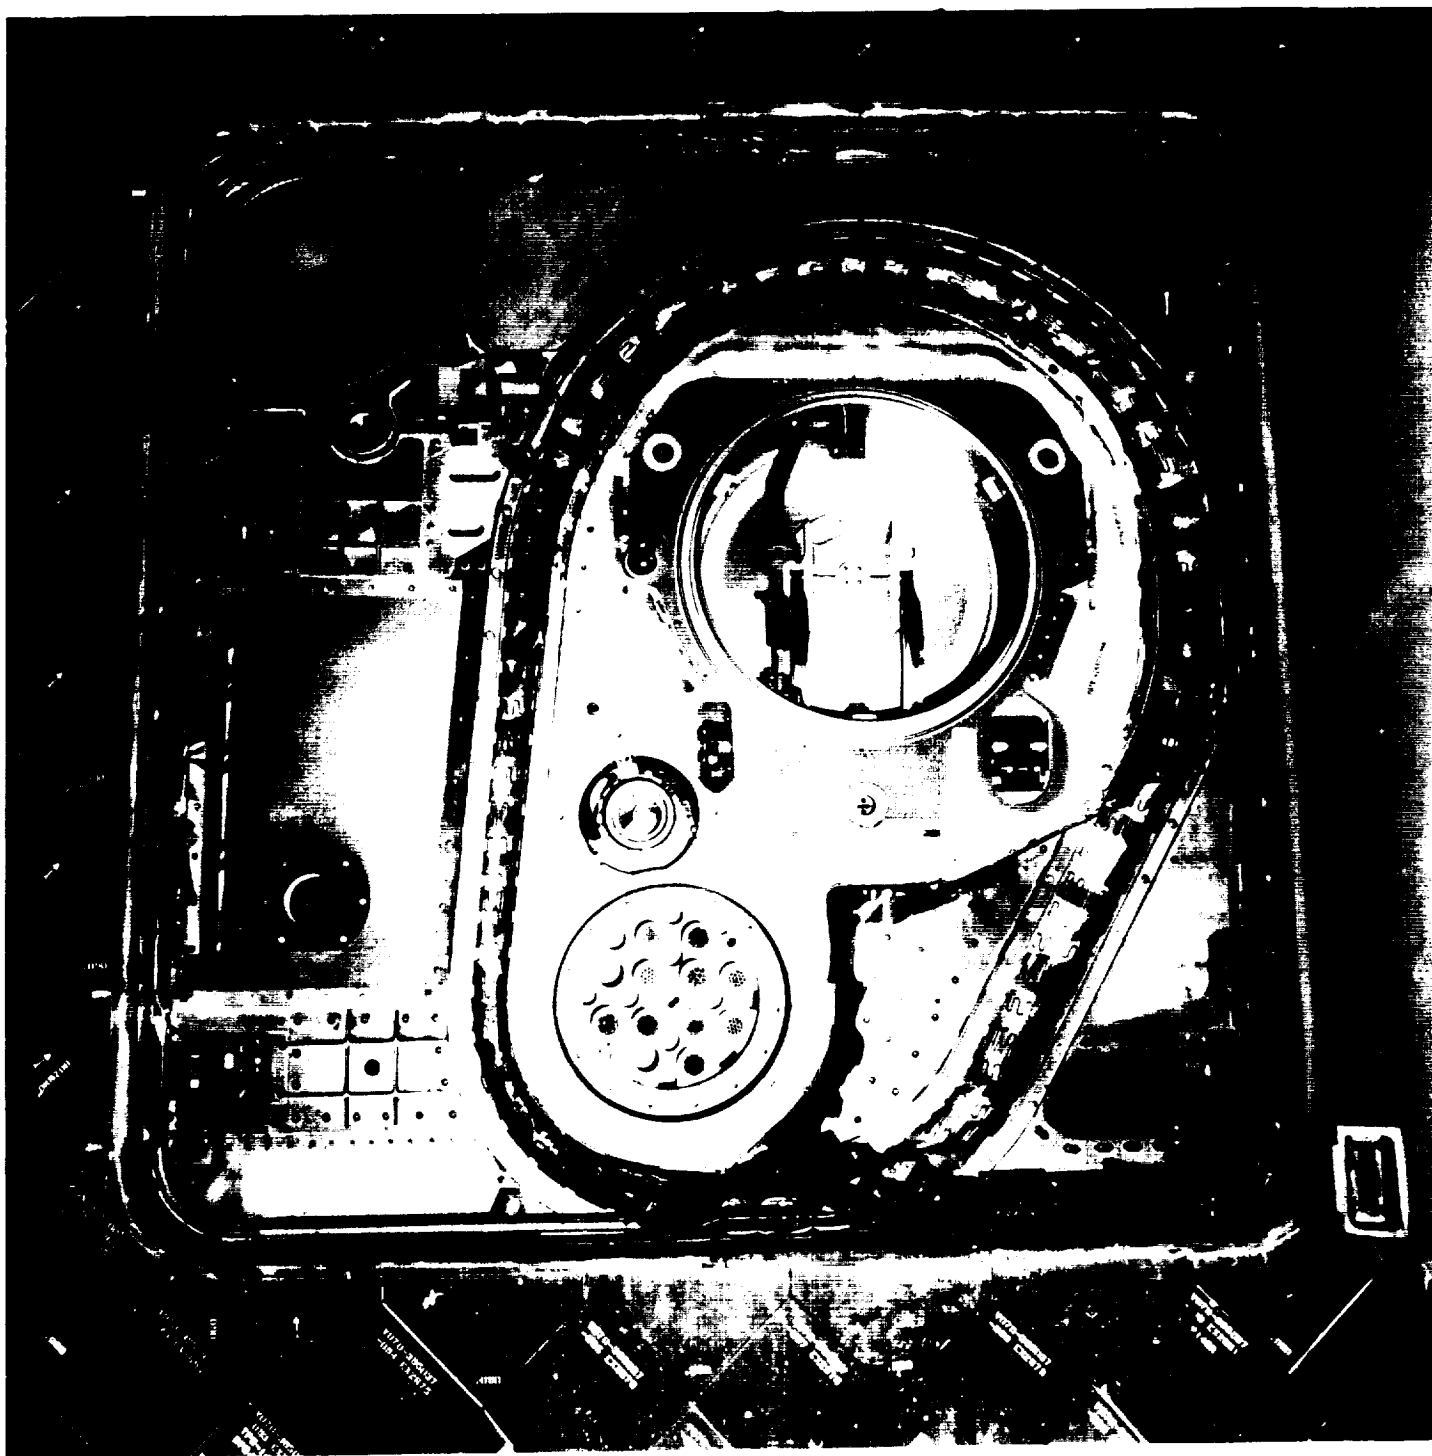
Overall view of the LO2 ET/ORB umbilical. All separation ordnance devices functioned properly. No flight hardware was found on the runway below the umbilical when the ET door was opened.

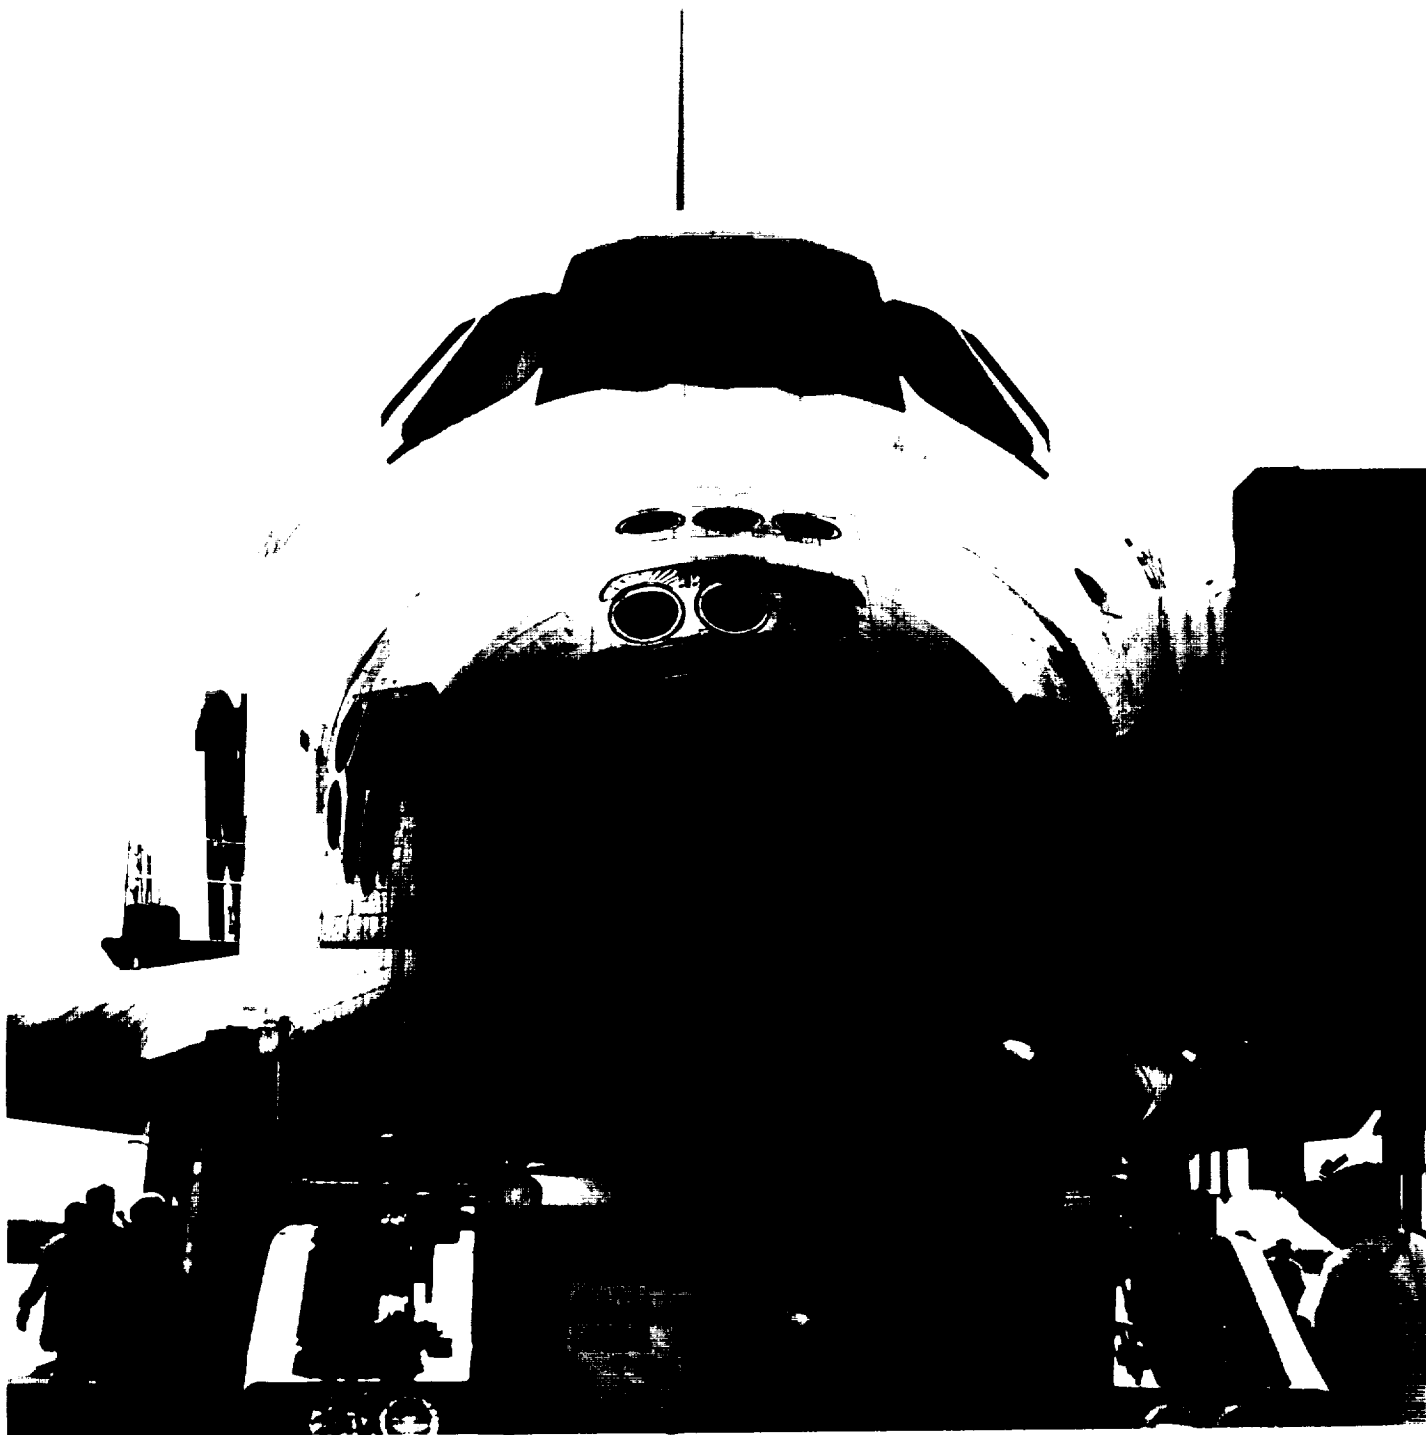
Orbiter windows #3 and #4 exhibited moderate hazing and several streaks. Only a very light haze was present on the other forward facing windows.

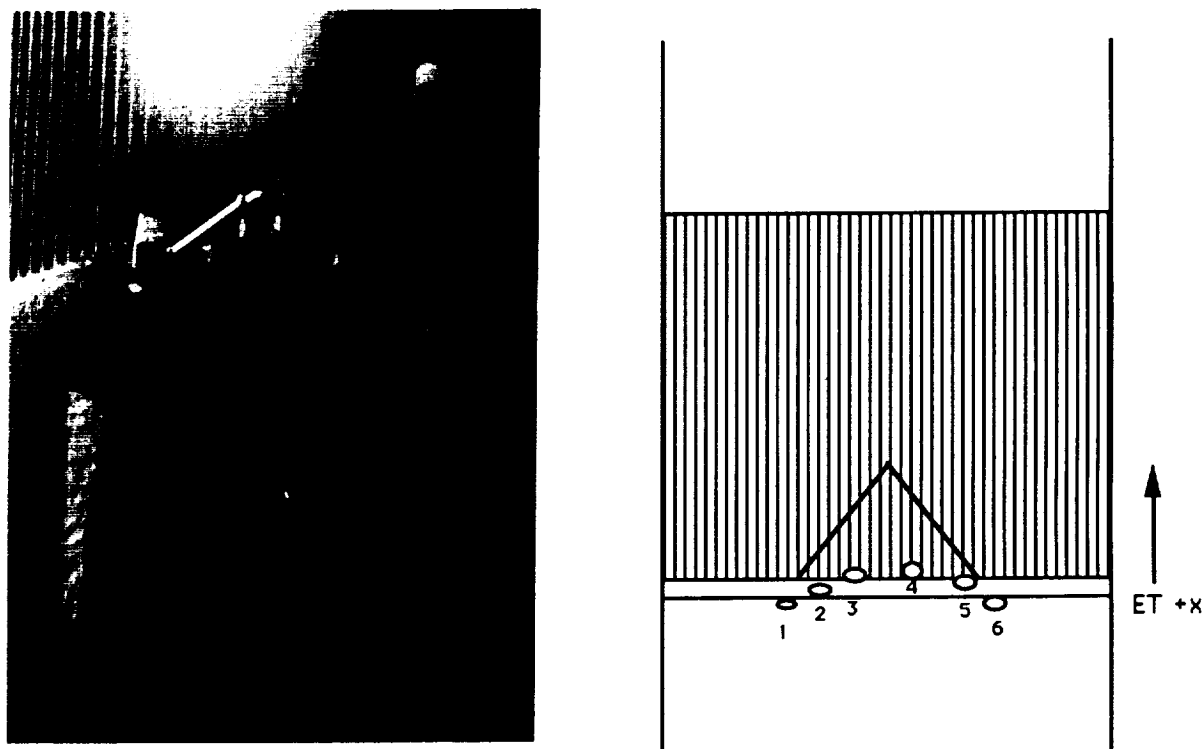
**Figure 2.4.2.3 (A) Divots Seen on ET TPS**  
(Frame STS-54-51-042)
